2013 Horseshoe Lake – MerRouge Aquatic Vegetation Control Plan

LDWF, Inland Fisheries

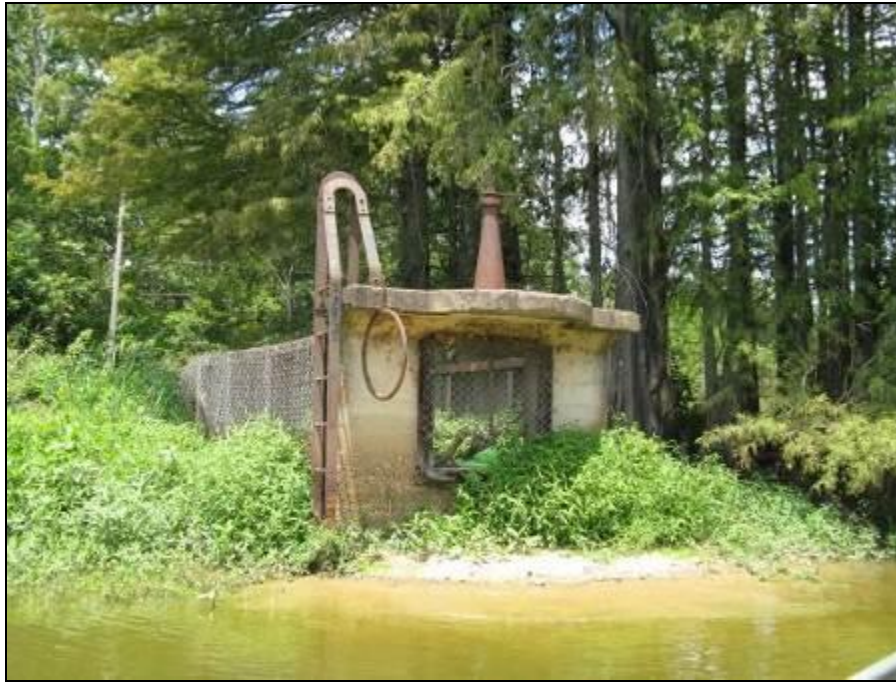
1. Waterbody type – Inactive oxbow lake formed by impoundment from Bayou Bonne Idee. The levee construction forming the current lake was completed in 1947.
2. Age and condition of control structure – Constructed in 1947, inoperable; the structure needs to be replaced.
3. Type of control structure – 3 ft. x 3 ft. concrete drop box with manually operated slide gate (size unknown) (Figure 1).

Figure 1. Horseshoe Lake control structure at 2.5 ft. below pool stage.

In 1993, the Lake Commission proposed a drawdown of the lake for repair of the leaking water control structure. The lake had reached levels over 2 ft. below pool stage. Lakeside residents overwhelmingly opposed this drawdown and the effort was abandoned. The structure has remained inoperable.
